## Queensland BHP Steel: diagnosis of a fan bearing problem

by Peter Cleary

and David Eden

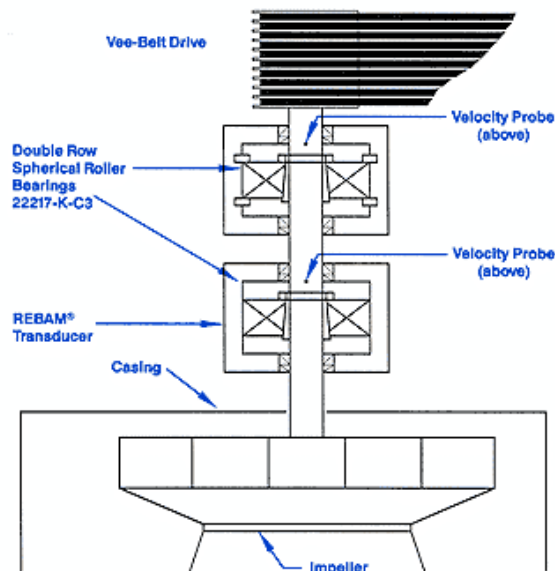
Figure 1  
Queensland BHP Steel's overhung impeller-type combustion air fan.

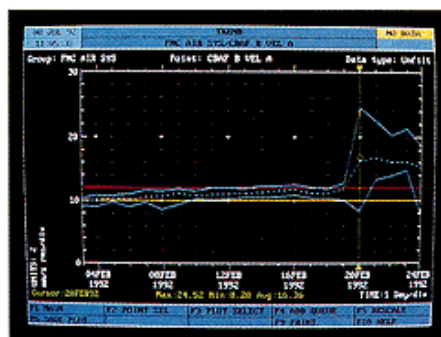
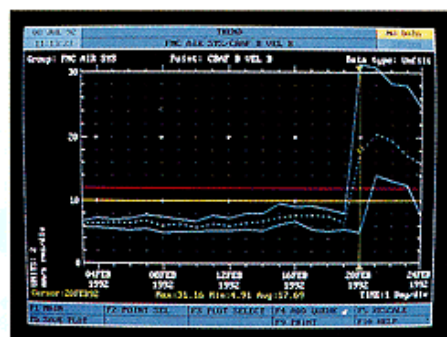
Figure 2  
Trend plots made by the velocity transducers (left, A; right, B) showing a sudden increase in amplitude.

A velocity transducer was installed on each plunger block and connected to the Trendmaster® 2000 System. The next temperature excursion was reported on 20 February 1992, the same day that both Trends made by the velocity transducers underwent a sudden increase in amplitude (Figure 2). In addition, the Spectra of the velocity transducer signals showed a sizeable increase in energy at 2X shaft speed (Figures 3-4). The maximum amplitudes of the velocity probe signals had been increasing slowly, but steadily, before the sudden increase in amplitude. The minimum amplitudes also changed but not as consistently as the maximum amplitudes.

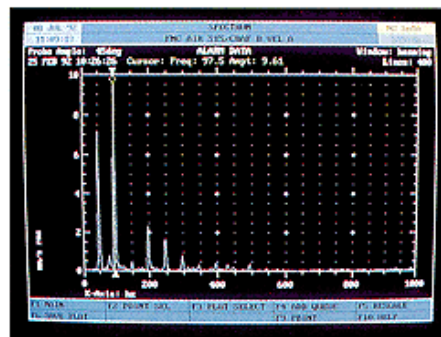
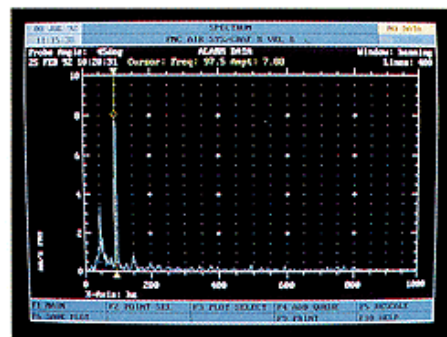
Figure 3  
Spectrum plots made by the velocity transducers (left, A; right, B) showing a sizeable increase in energy at 2X shaft speed.

Close inspection of the Spectrum of the pulley end velocity probe signal (Figure 3) showed that the broad band of frequencies above and below shaft speed contained small peaks. When they were first noticed, it was apparent that they were mostly multiples of approximately 10 Hz. The length of the vee-belts was approximately five times the pitch circumference of the fan pulley, implying that the fundamental frequency of the belts was about 10 Hz. Thus, the broad band of frequencies around shaft speed could be confidently associated with a deterioration in vee-belt condition. The spacing between the small peaks later

became somewhat less regular, and peaks appeared at other frequencies.

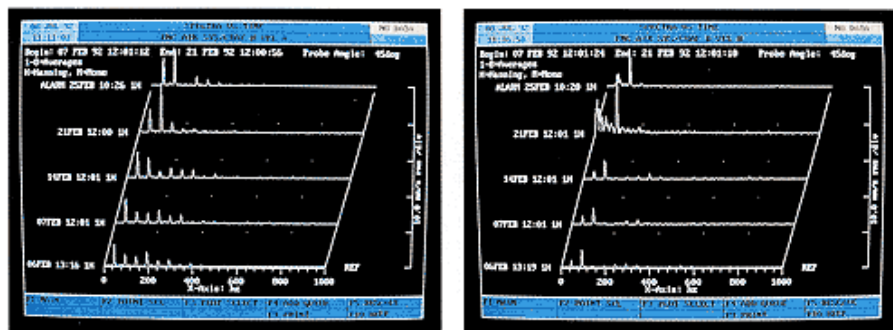
Figure 4  
Spectra versus Time plots made by the velocity transducers (left, A;  
right, B) showing increasing energy at 2X shaft speed.
